SCHUYLKILL TOWNSHIP

BOARD PRESENTATION • NOVEMBER 8, 2023

FEASIBILITY STUDY OVERVIEW

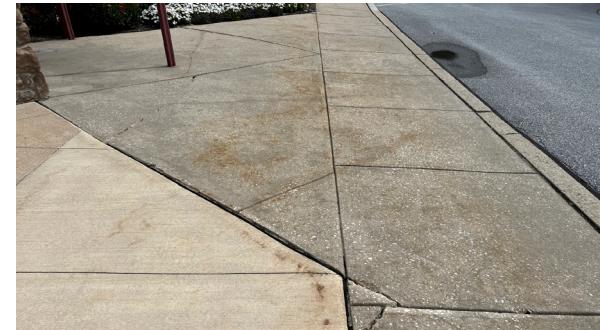
Notes: The sidewalks are in overall good condition with no major issues to be addressed. Other than some minor cosmetic issues such as some discoloration and minor cracking, the sidewalks do not need immediate attention.

Discolored sidewalk

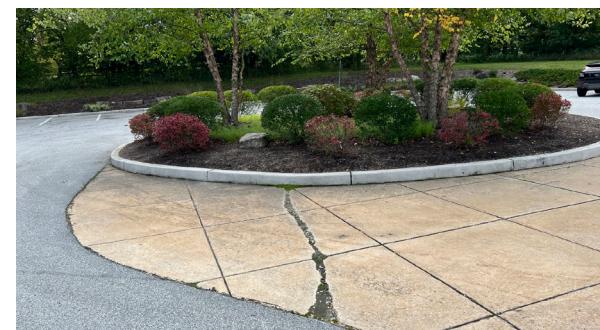
Notes: The parking lot is in overall okay condition but lacks functionality. In the upper lot (admin), the concrete island has substantial cracking and is the source of wasted space and lack of parking spots. In the lower lot (police), parking is limited and is shared with users of the community park. It should also be noted that the ADA designated parking spot is located within the roadway and should be relocated.

Damaged concrete

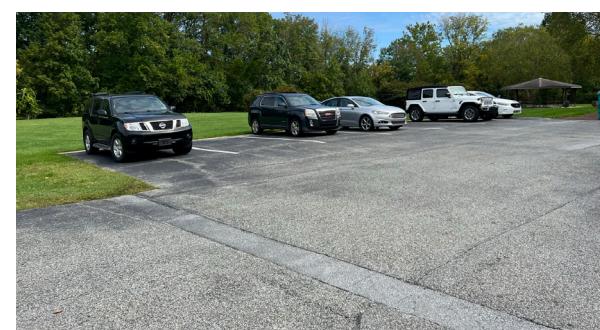
Notes: There is one main roadway that takes you to the upper lot and lower lot. While it is in overall good condition, there are quite a few patched areas and lacks circulation markings.

Lower level parking

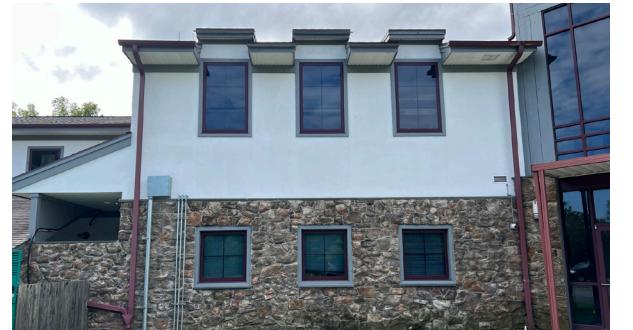
Notes: Wood framed upper-level exterior walls sit on concrete masonry lower-level foundation walls. Exposed storage room on first floor shows faced insulation in stud cavity (R-19) with no signs of moisture damage to insulation or wood structure.

Typical exterior wall

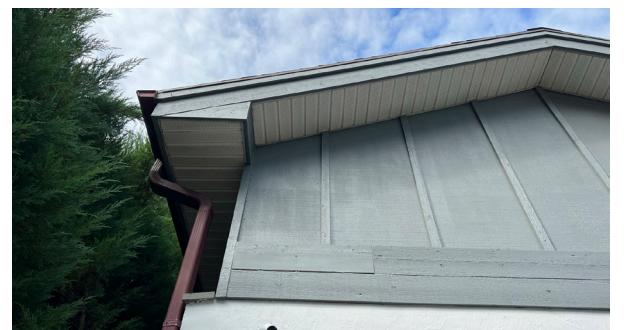
Wood siding & aluminum soffits

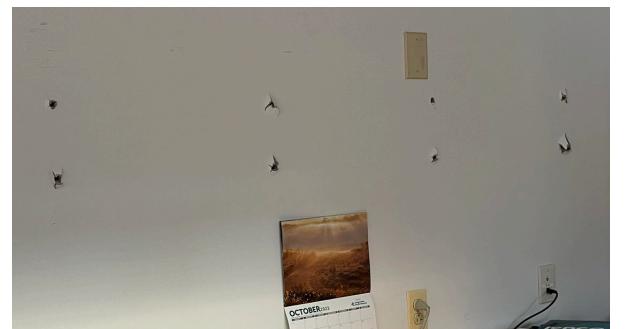
Notes: The interior wall construction is a combination of wood studs with gypsum wall board and concrete masonry units. Interior walls are in okay condition with some minor wear and tear on the drywall, particularly in the office area. The storage room in the admin area is unfinished with insulation and wood studs exposed.

Damaged drywall

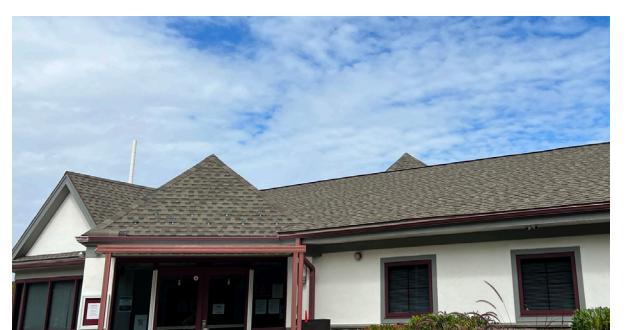
Notes: All asphalt shingles viewed were in place – no detachment. Shingles appear to be overlapped correctly. The roof deck sheathing visible from the underside of the roof was in good condition. Vented eave soffits and ridge vents seen on all roof areas. Insulation within the roof cavity showed no visible sign of moisture damage.

Asphalt shingle roof

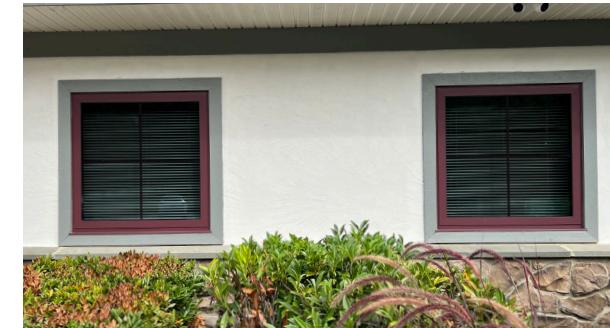
Notes: The windows throughout the building consist of aluminum casement windows with interior wood sills. Although the windows appear to be in good condition, it should be noted that the township has expressed dissatisfaction as they leak and are drafty. The windows should be weather sealed to resolve this issue.

Typical windows

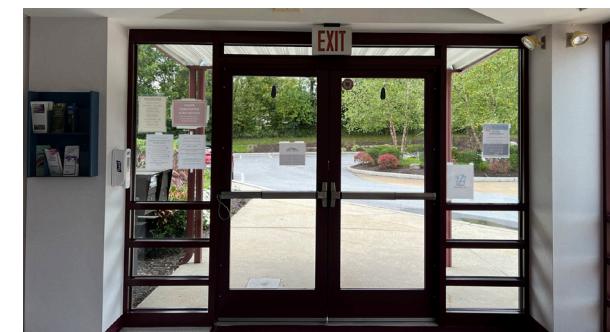
Notes: The security of the building is in average condition. The main entrance on both levels have an intercom and buzzer system that brings visitors directly into the building. Although there is keyed access into the administrative and police suites, visitors can access both levels upon entry.

Main entrance doors

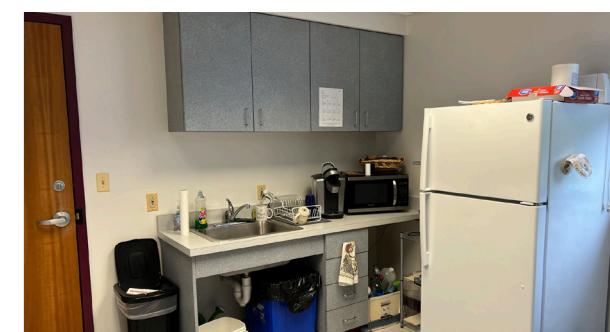
Notes: Storage and casework throughout the building consist mostly of plastic laminate cabinets and countertops. It is recommended that countertops with sinks are solid surface. Storage rooms in the administration and police department lack space and functionality. Admin file storage is located in an unfinished room that contains IT, MEP, and janitorial equipment. File storage is also located off site in the original township building. Police department storage has similar space and adjacency issues and also lacks lockers for police office use.

Upper level break room casework

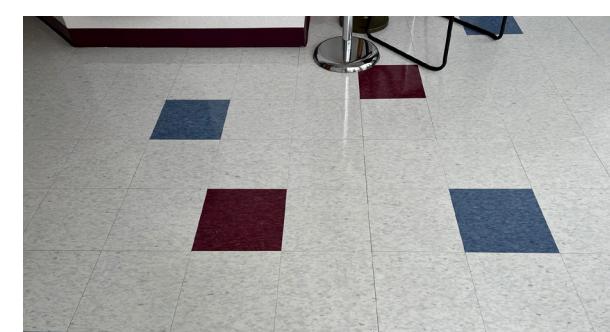
Notes: While outdated, the finishes throughout the building are in okay condition. The flooring consists of VCT in hallways, break rooms, and most of the police department. Broadloom carpet is used in office spaces and the meeting room, which is not a recommended material for these spaces. Bathrooms have 2" x 2" tiles on the floor with partial height ceramic tile going up the walls. The hallways and main lobbies have wall paper finish which is peeling at the seams.

Lobby/corridor VCT

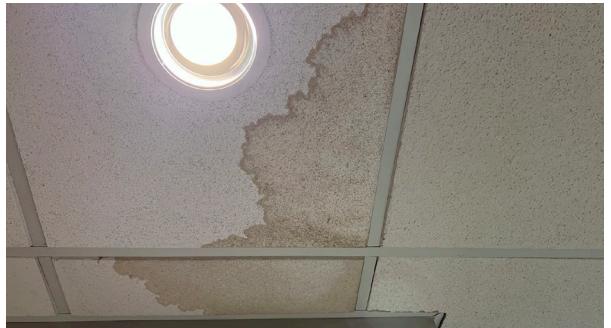
Notes: The ceilings are a combination of acoustic ceiling tiles and hard gypsum board at soffits, lobbies, and the meeting room. There is discoloration present on a few ceiling tiles due to water damage. Other than these minor issues, the ceilings are in good condition.

Damaged ceiling tiles

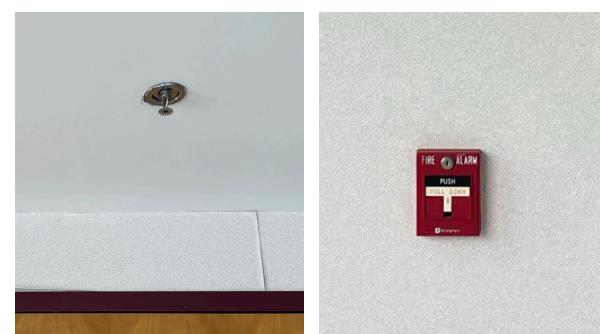
Notes: System in good condition – although likely original to the building. Sprinkler head coverage seen in all rooms.

Sprinkler head & fire alarm pull station

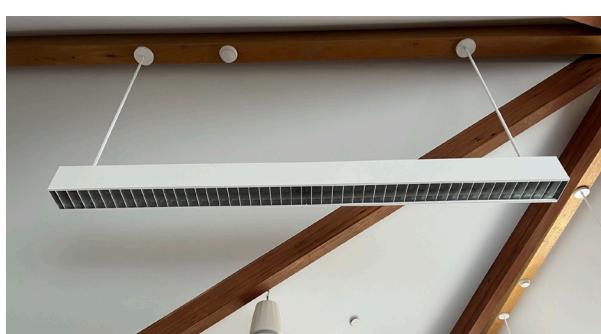
Notes: Lighting is outdated. It is recommended to upgrade to LED technology interior lighting in all locations.

Meeting room light fixture

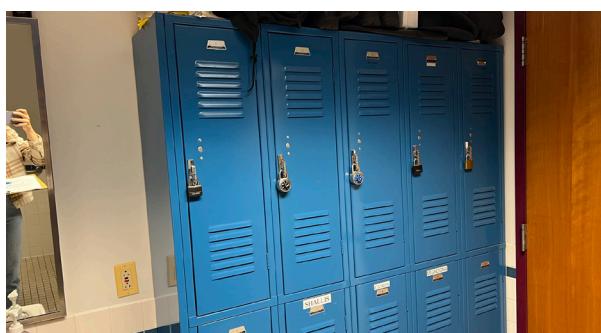
Notes: The police department currently lacks a locker room that aligns with the townships' requirements and standards. Lockers are currently located in the restroom which is shared by both women and men. This arrangement not only falls short of meeting the department's needs but also fails to meet established standards. Moreover, the lockers' placement within a single-stall restroom has resulted in a serious space constraint that should be addressed.

Officer lockers

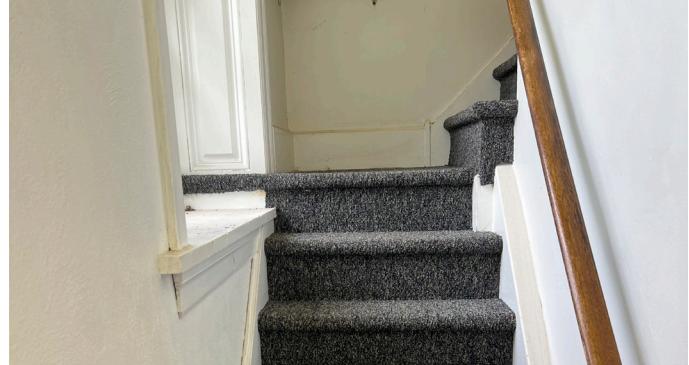
Non code compliant stair

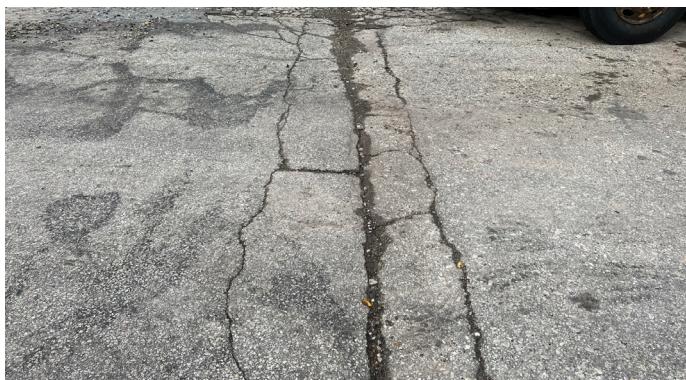
Cracking asphalt pavement
