SCHUYLKILL TOWNSHIP

BOARD PRESENTATION • NOVEMBER 8, 2023

FEASIBILITY STUDY OVERVIEW

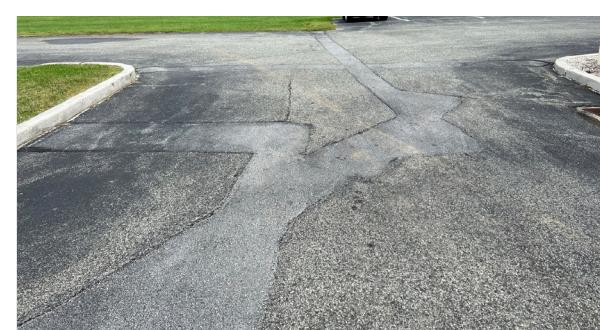
Patched asphalt roadway/parking

Notes: There is one main roadway that takes you to the upper lot and lower lot. While it is in overall good condition, there are quite a few patched areas and lacks circulation markings.

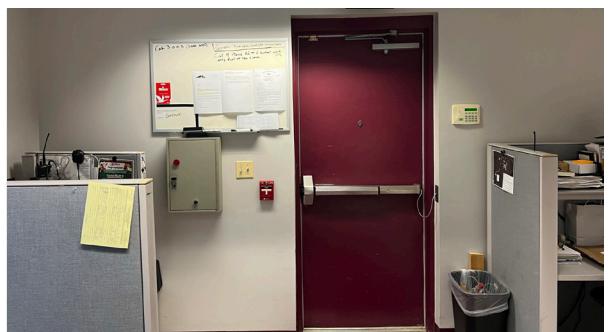
Notes: Besides general wear and tear, the doors throughout the building are in good condition with ADA-accessible hardware. They consist of a combination of wood and hollow metal doors with hollow metal frames. Main entrance doors are aluminum and glass and are in good condition.

Hollow metal door

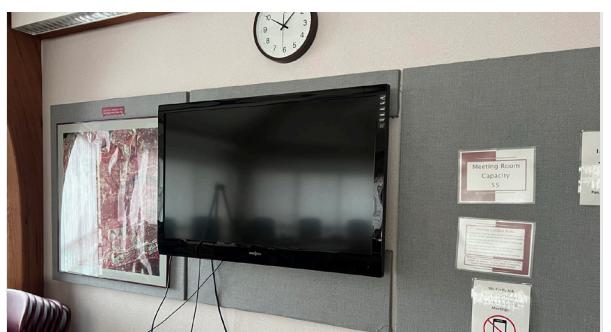
Notes: Technology throughout the building is in good condition but could use some modern upgrades. In the administrative suite, each office workstation is equipped with a desktop computer and phone. In the meeting room, there is a TV for sharing presentations, microphones at the dais, and a sound system throughout. In the police department, there are shared desktop computers in the open office area and in private offices. There is also a TV in the shared office area for training. Each workstation is equipped with a phone.

Meeting room technology

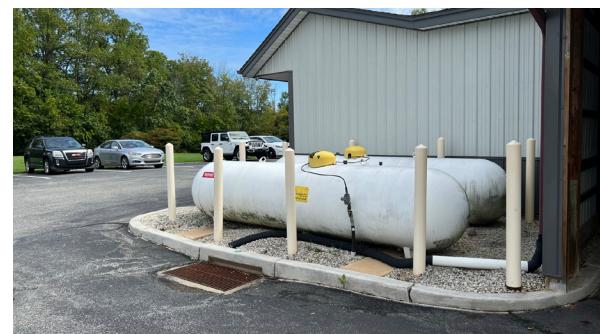
Propane tanks

Notes: The generator system appears to be oversized for the loads served, which is good for future growth of IT Systems, Security, and Heating Systems. Generator is served by (2) propane tanks adjacent to parking areas for police.

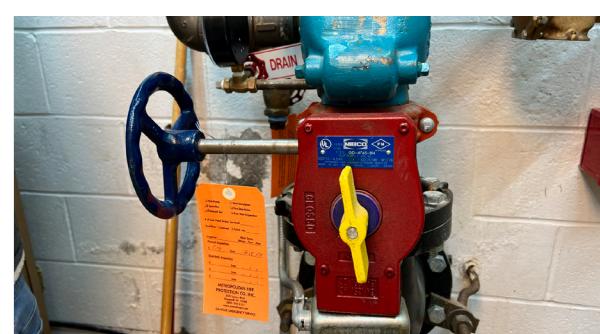
Notes: System in good condition – although likely original to the building. Sprinkler head coverage seen in all rooms.

Sprinkler control valve

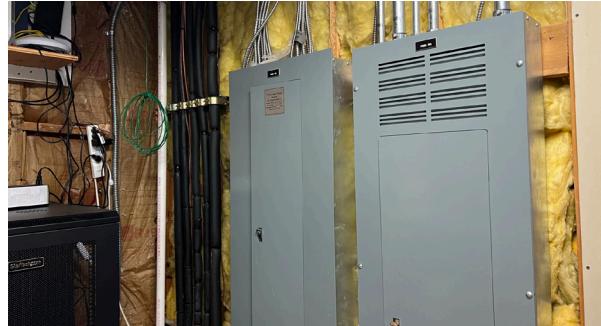
Notes: The main electrical service is in good condition. There is a main panel in the utility room downstairs and addition sub-panel in storage room upstairs off the administrative suite. The building is primarily electrical in consumption as expected from original construction in the 1990s. Breaker panels, distribution lines, and other system parts are in good condition. The main panel in the utility room ties into the generator.

Electrical switchboards

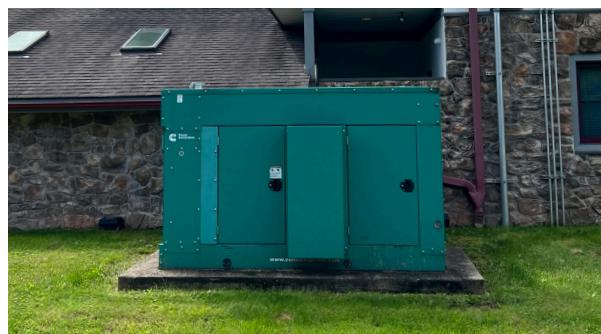
Emergency generator

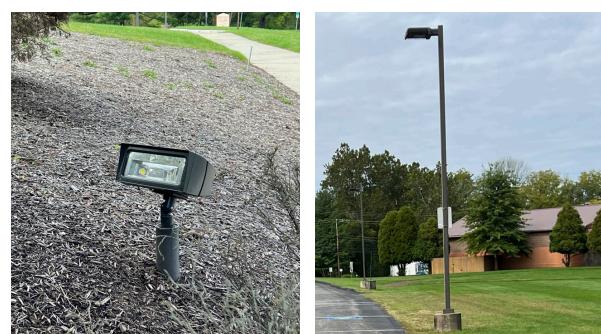
Notes: Fixtures appear to be original to construction.

Site lighting

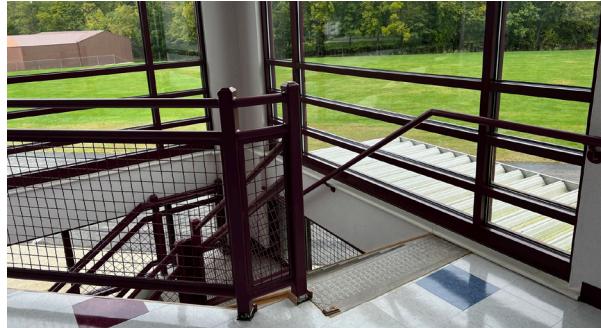
Notes: The circulation throughout the building is poor and causes a variety of issues within both the Administration Department and Police Department. The entrances on the upper and lower levels lack vestibules which allows visitors to access the main building corridors. The circulation process of bringing someone in for questioning is troublesome and should be addressed.

Stairwell

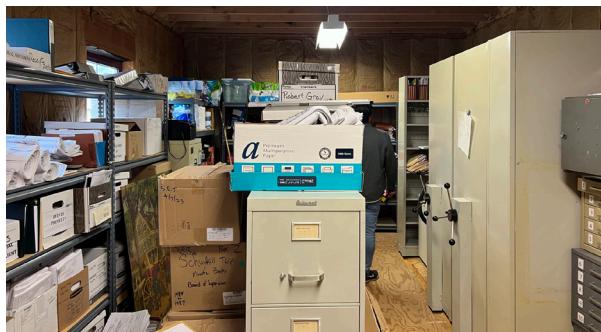
Notes: Adjacencies both within the township building and across the site are currently suboptimal and require significant enhancement. A key concern is the separation of the administration suite from its storage area, which is situated in a different building on the premises. Additionally, inadequate storage room adjacencies pose considerable challenges within the police department, impacting daily operations. It is evident that the police department's operations have evolved over the years, deviating from the intended design of the space. Therefore, there is a pressing need to comprehensively address the layout to enhance adjacencies and overall operational efficiency.

Storage, IT, and mechanical room

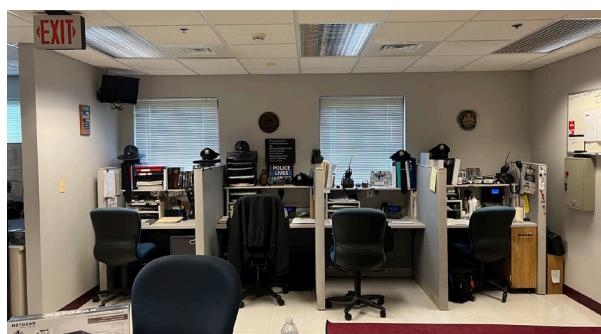
Notes: Insufficient general storage poses a significant challenge within both the administration suite and the police department. The primary issue revolves around the inadequacy of storage space, leading to a range of operational difficulties. Notably, the storage room in the administrative department serves multiple functions as a janitor closet, IT closet, and mechanical closet, which compromises operational efficiency. It is highly advisable to separate these functions to optimize their roles.

Officer workstations

Similarly, the police department lacks essential general storage solutions, resulting in the inappropriate use of holding cells for storage purposes. To address this issue effectively, dedicated and appropriate storage rooms should be provided within the department to ensure efficient and secure storage of essential items and equipment.

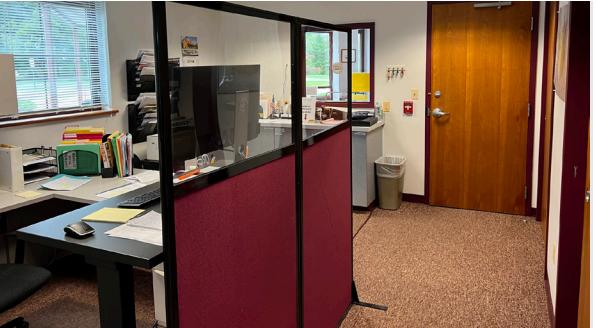
Notes: With a large amount of open office area within the administration and police departments, visual privacy is lacking. Most workstations are equipped with division panels and or space dividers which provides some visual privacy, but does not meet the needs of either department. Private offices should be provided to accommodate visual privacy needs.

Administrative open office area

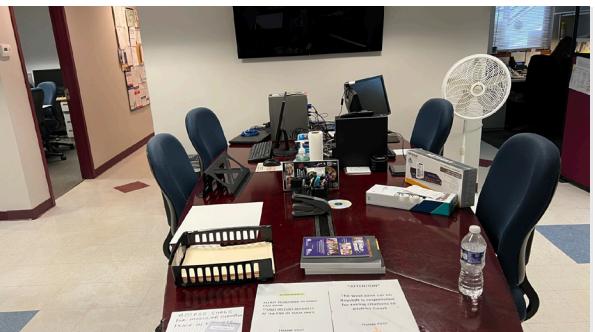
PD shared work area

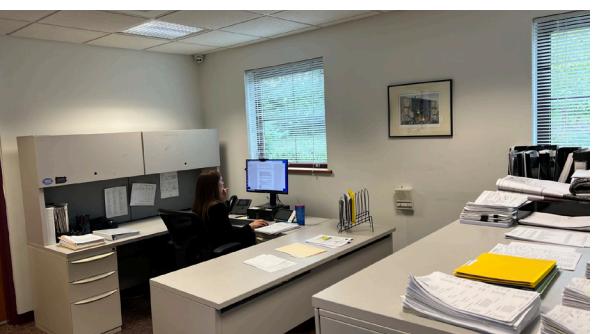
Open workstation

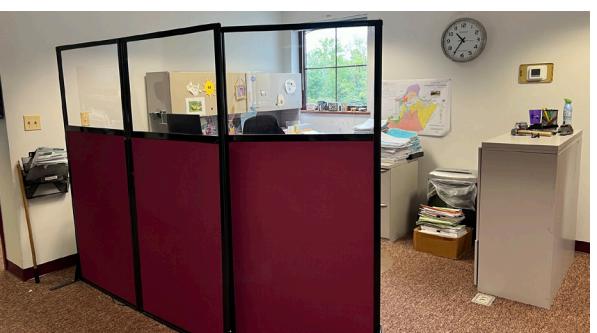
Visual space divider

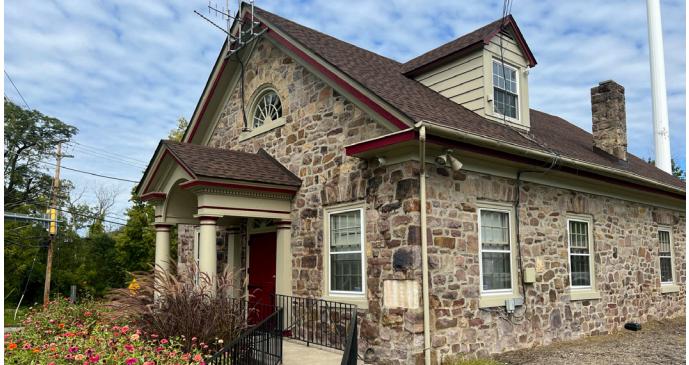
Overall building

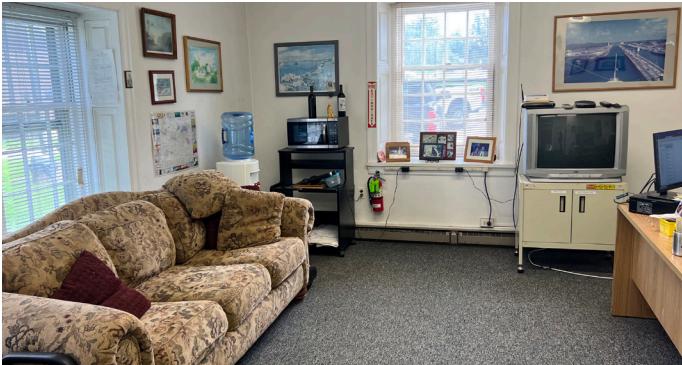
Overall office interior

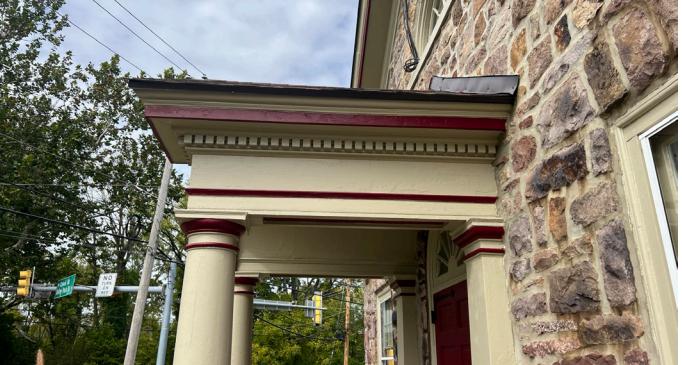
Roof canopy

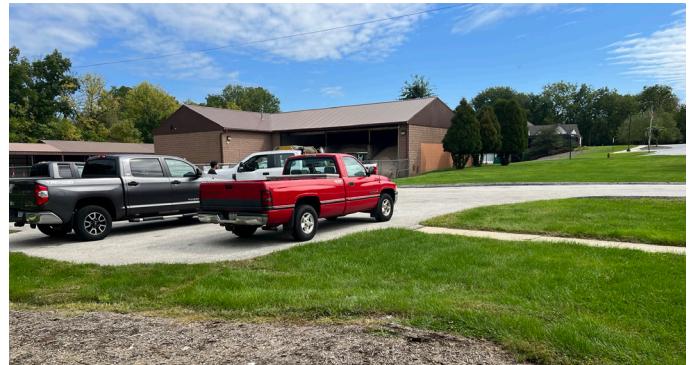
Parking lot

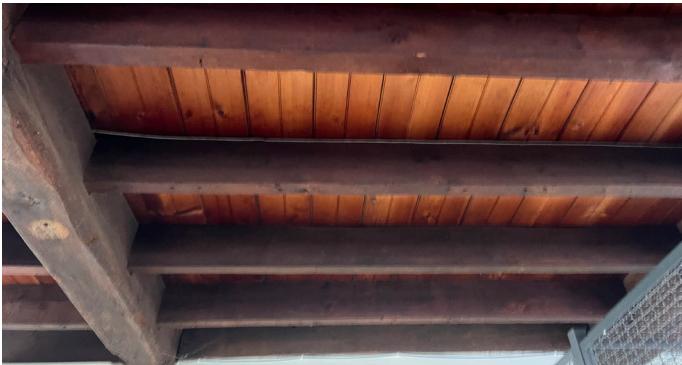
Exposed wood structure

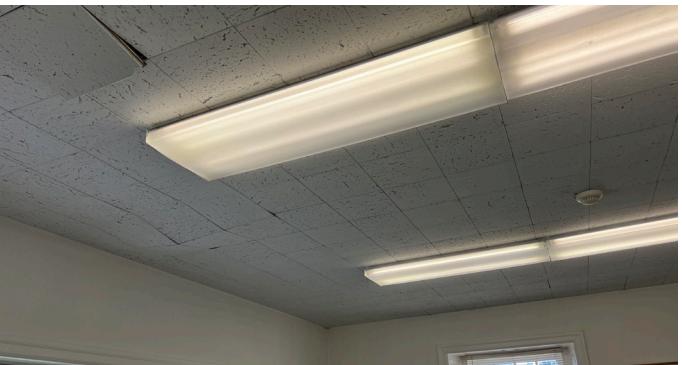
Ceilings and interior lighting

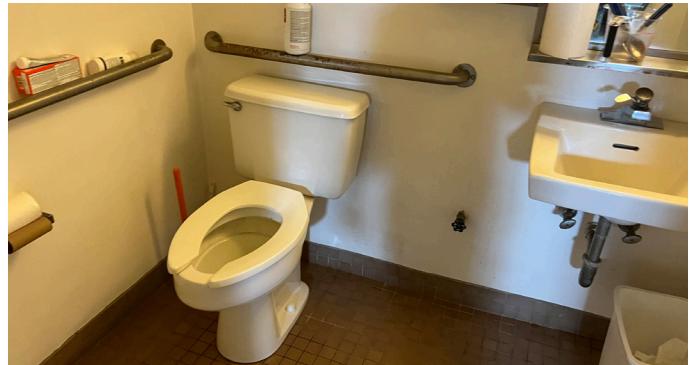
Non code compliant restroom

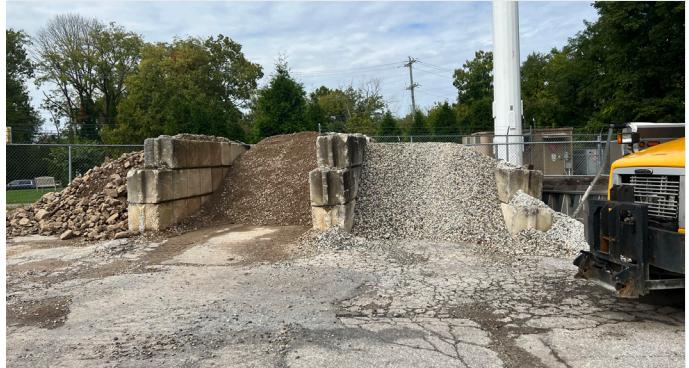
Site materials

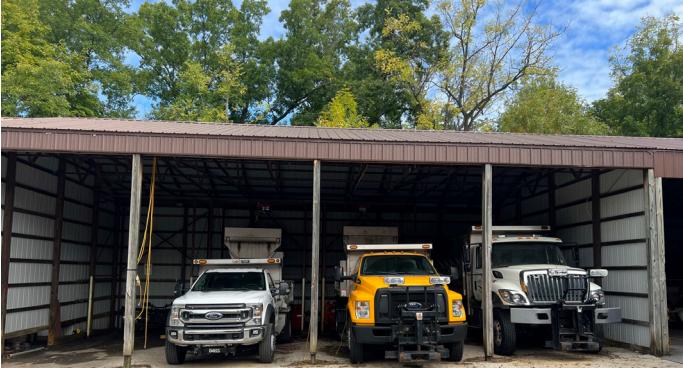
Parking structure

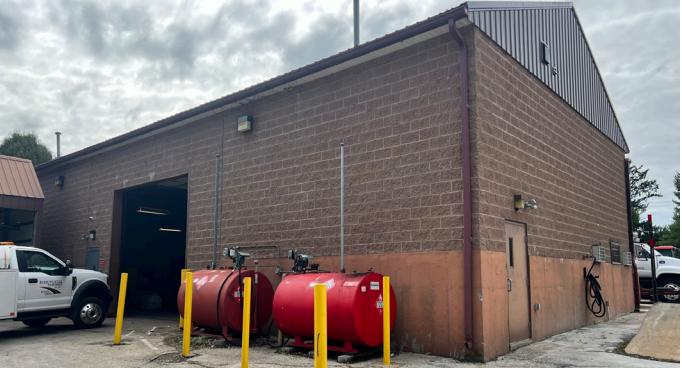
Main garage building

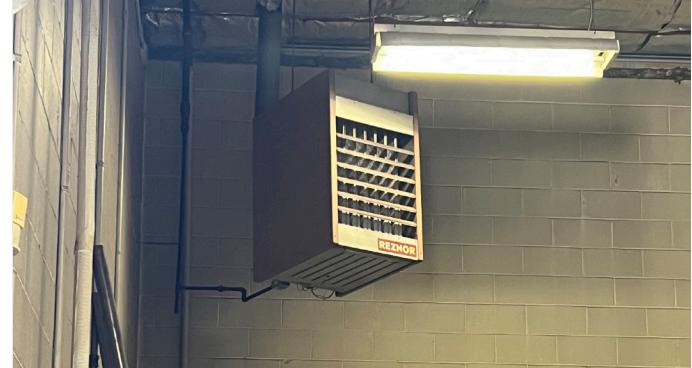
Heater

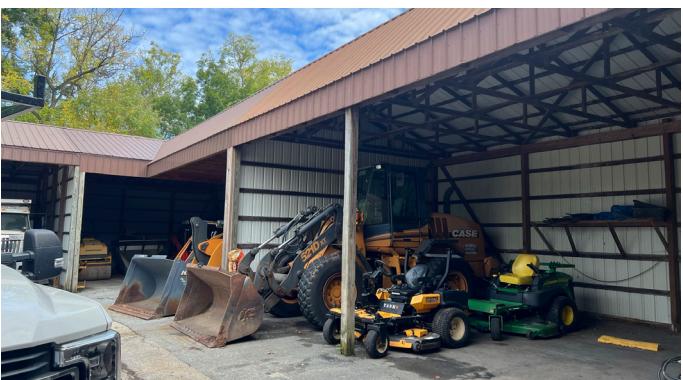
Equipment structure

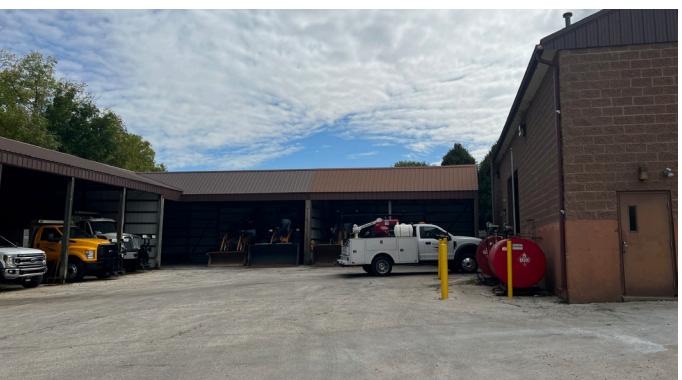
Overall site

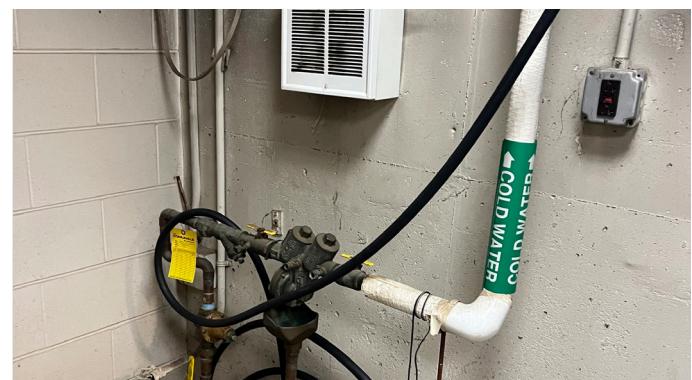
Water service

Notes: Domestic utility water service is satisfactory. No action recommended.
